# Section 19 Flood Investigation Report

Date of Flood Incident: 17<sup>th</sup> -18<sup>th</sup> September 2023, 13<sup>th</sup> & 20<sup>th</sup> October 2023

Swindon Borough Council, February 2025

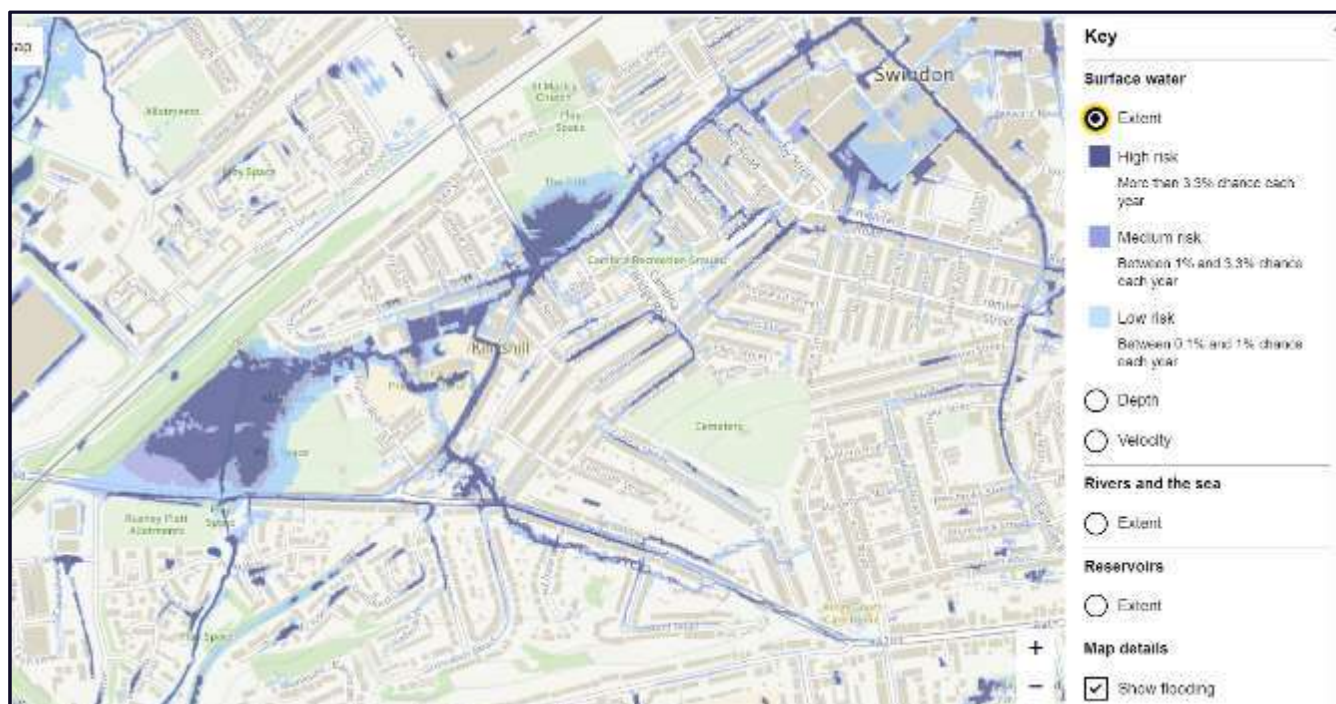
Figure 5 Environment Agency Surface Water Flood Map for Central Swindon

The flooding here is assessed to have been caused by intense rainfall event on this urbanised catchment which quickly overwhelmed the local drainage network. Excess water unable to access the network due to in part to blocked and surcharged drainage, subsequently flowing across the ground surface into properties. There was anecdotal evidence of blocked road gullies, which apparently had been reported to SBC by local residents on previous occasions but not managed. These were subsequently cleared by SBC Operations following the incident.

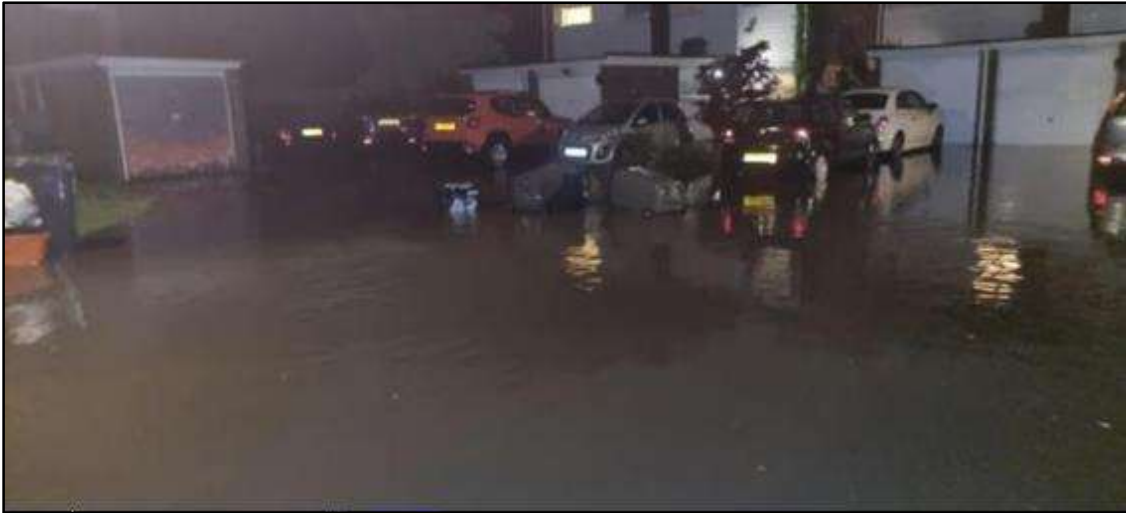
Figure 9 Photo showing flooding to residential carpark area

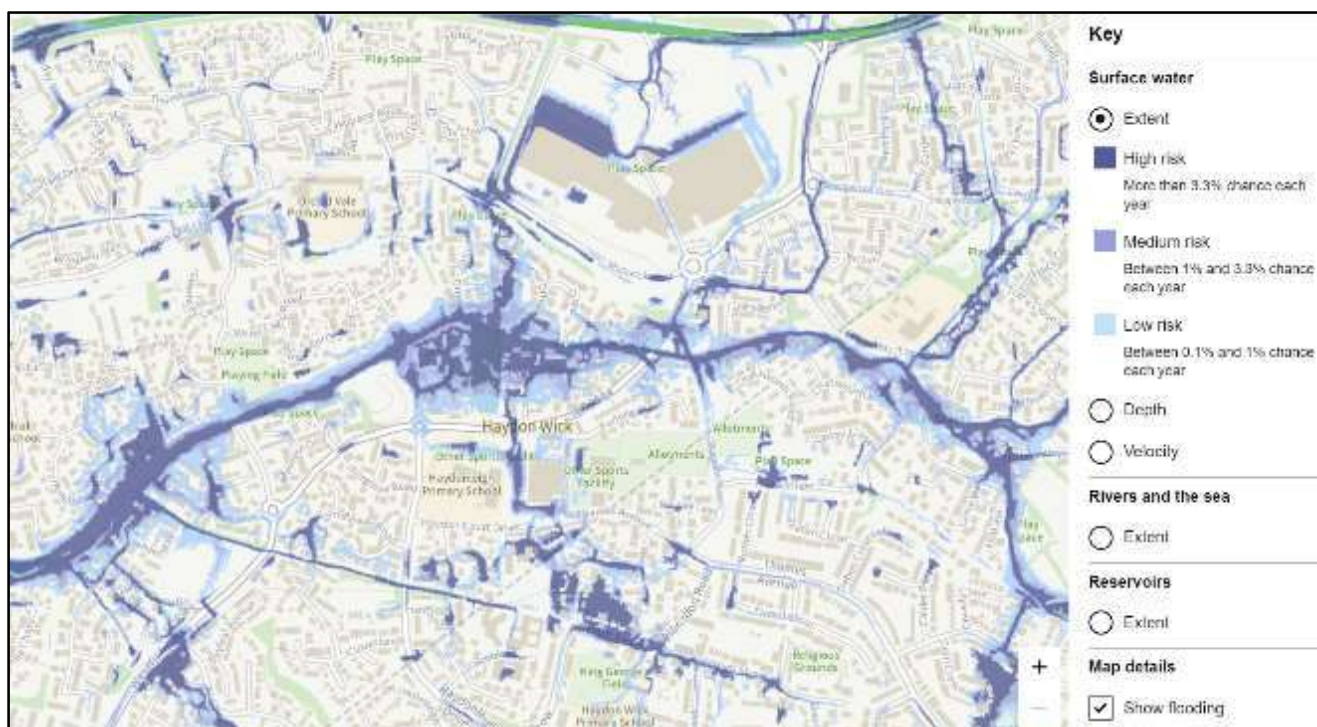
Figure 12 Surface Water Flood Risk for Haydon Wick Parish

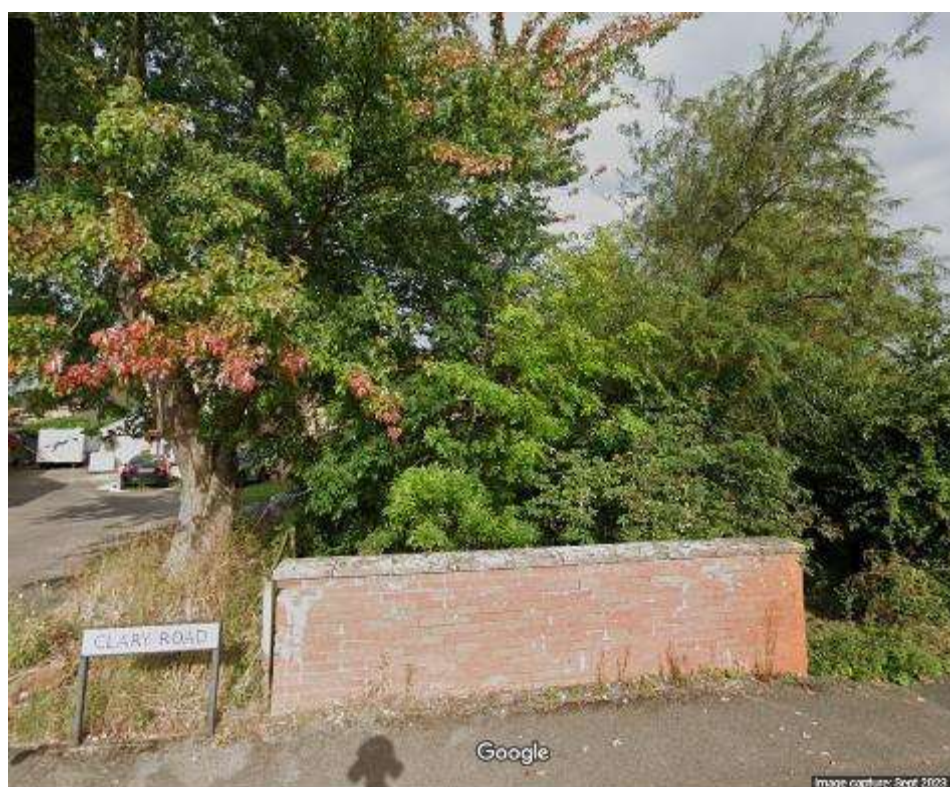
Figure 13 Overgrown watercourse channel - Clary Road (Main River Section)

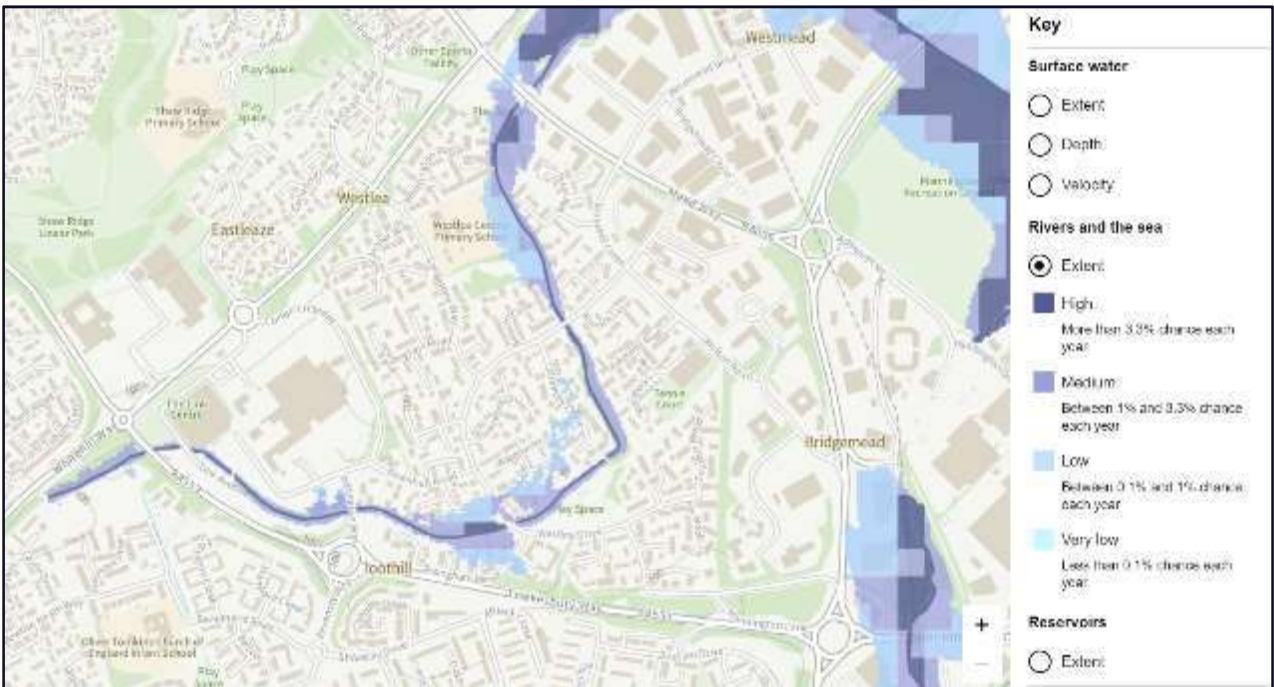
Figure 17 Fluvial Flood Risk Map - Whitehill Stream area Westlea and Toothill areas

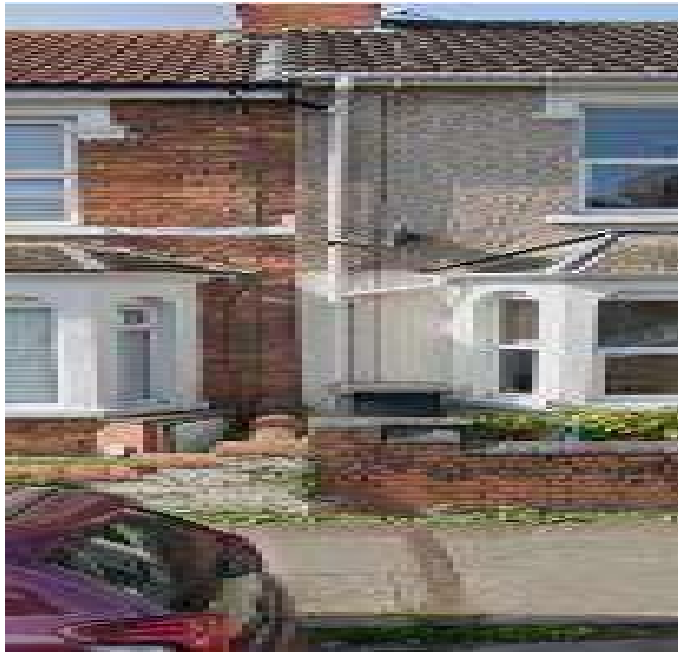
Figure 20 Shared roof drainage downpipe discharging onto the highway footpath in Montagu Street

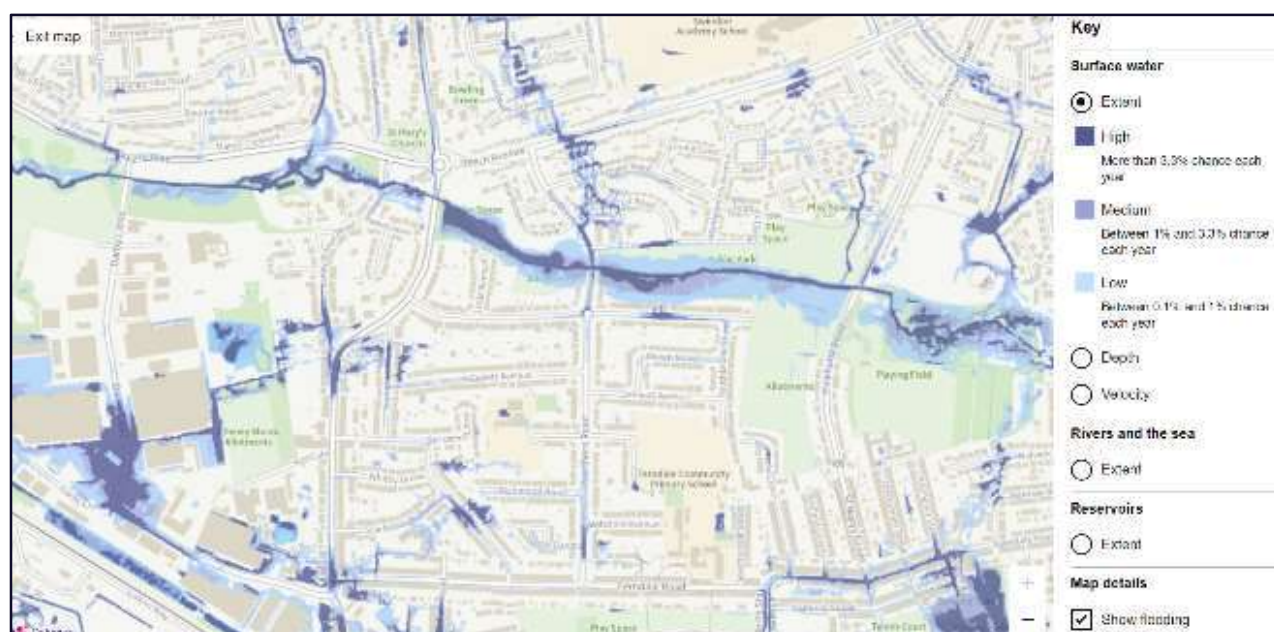
Figure 23 Surface Water Flood Risk Map for Rodbourne Cheney

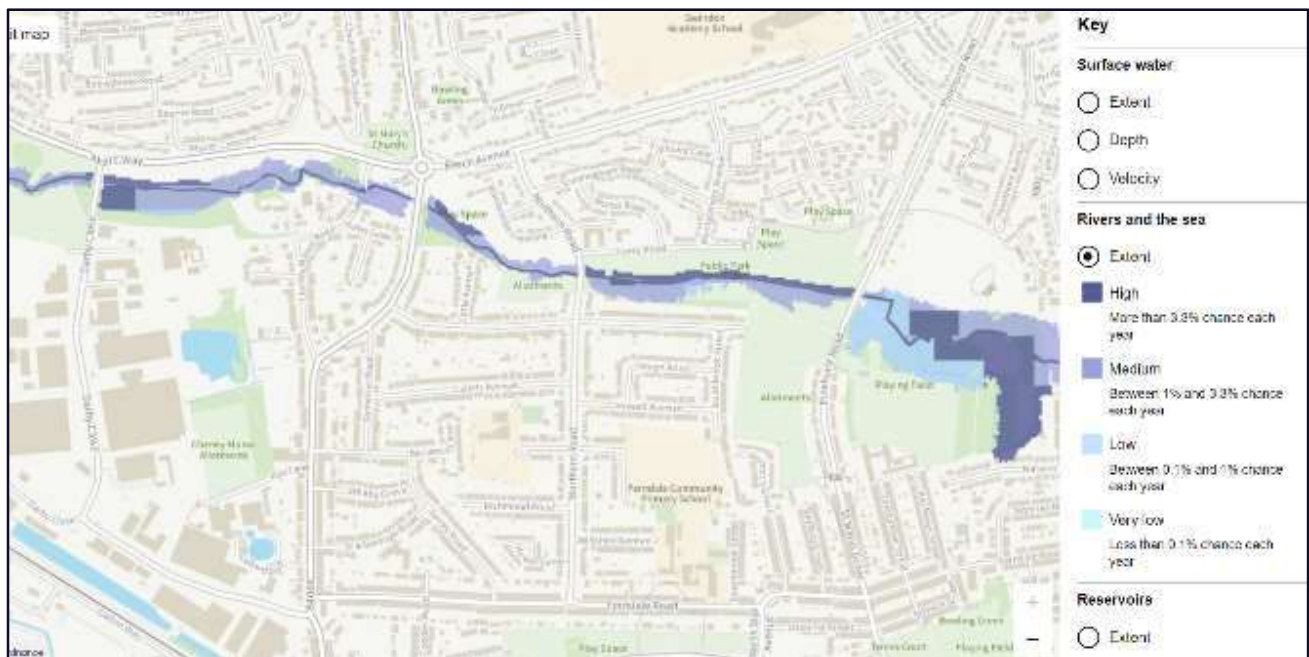
Figure 24 Fluvial Flood Risk Map for Rodbourne Cheney

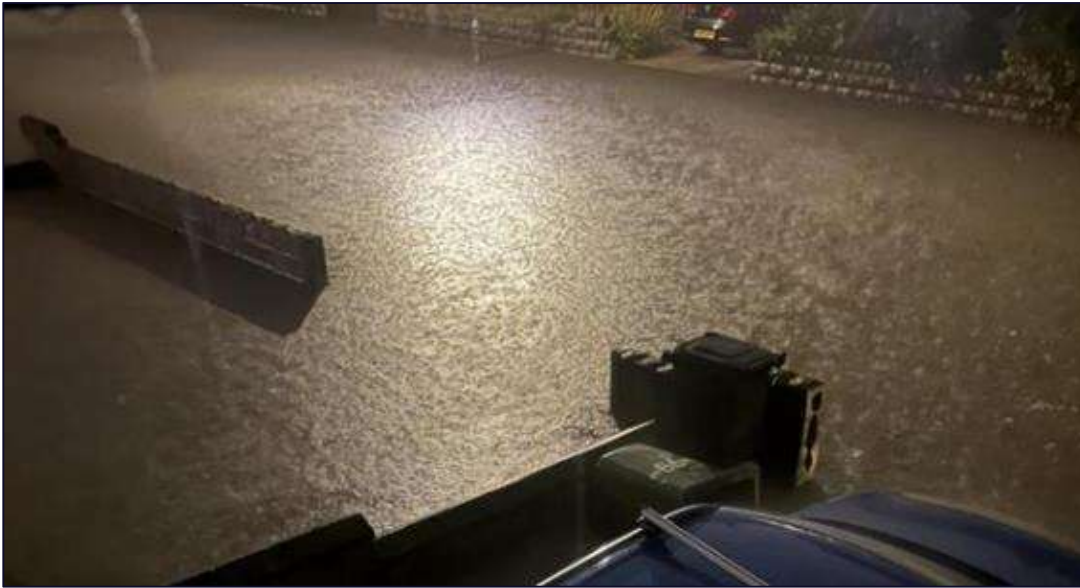
*Figure 26 Churchward Avenue – Photo Credit: Sarah Cumming (3 am ) – Swindon Advertiser*

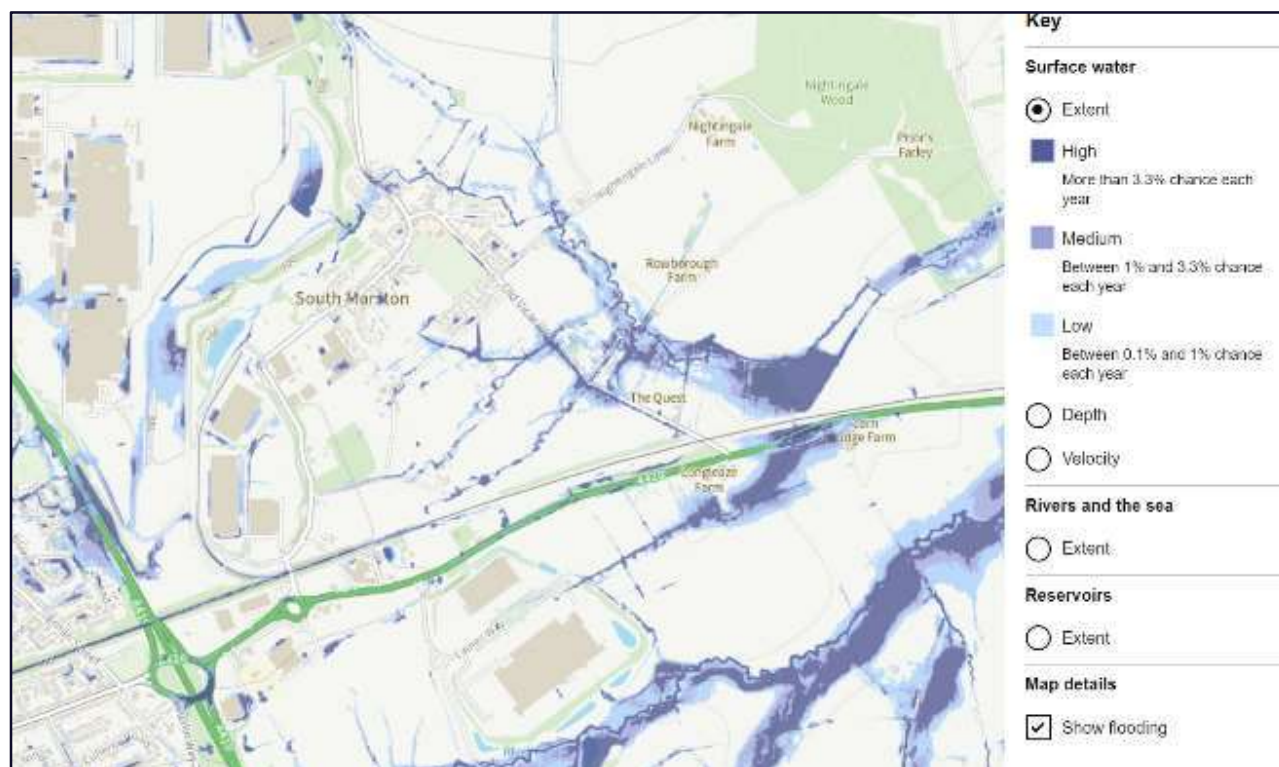
Figure 27 Surface Water Flood Map of South Marston

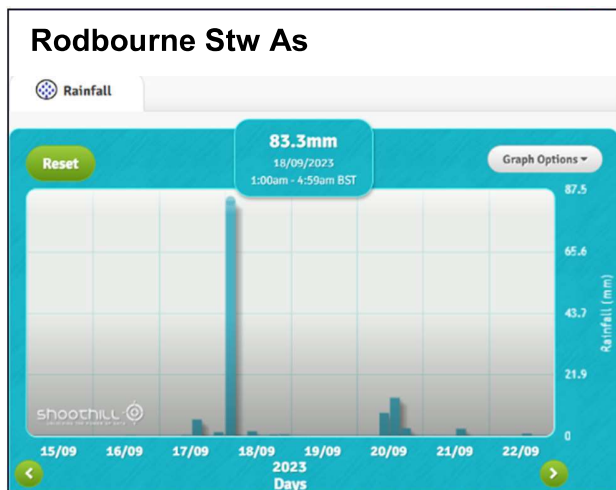
Figure 27 Graph showing rainfall records at Rodbourne Stw As (Shootherill)1

The above graphs demonstrate that the most significant event for Swindon was 17<sup>th</sup>/18<sup>th</sup> September 2023. The majority of rain fell between midnight and 5am which correlates with information received from residents.

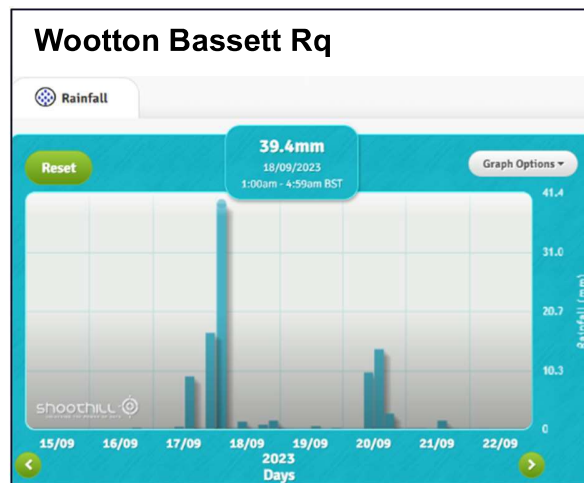
Figure 28 Graph to show rainfall records at Wootton Bassett Rq. (copyright Shootherill)

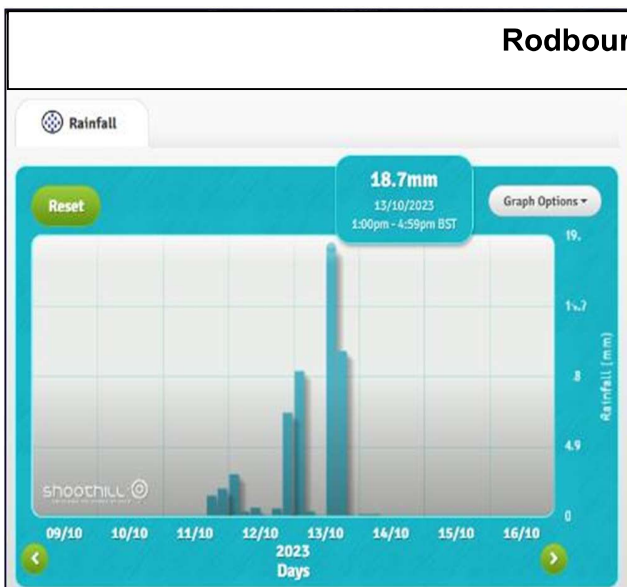
Figure 29 Graph to show rainfall records (Rodbourne Stw As) (Shootherill)

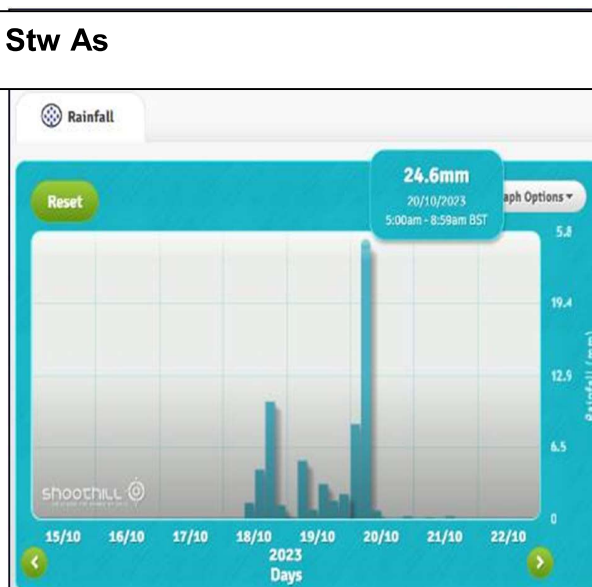
Figure 31 Graph to show rainfall records (Rodbourne Stw As) (Shootherill)

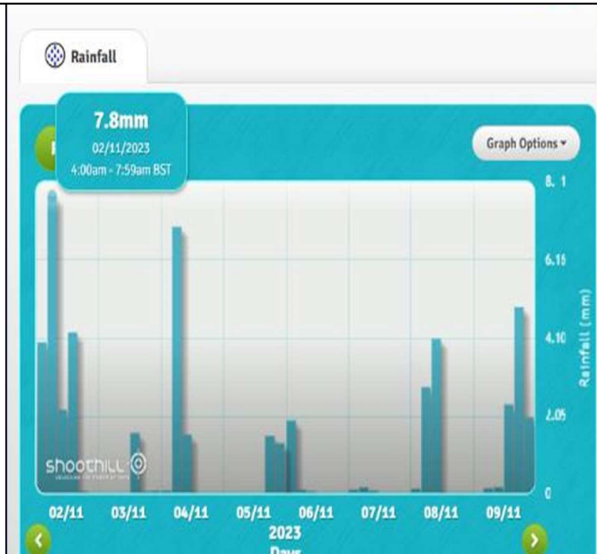
Figure 34 Graph to show rainfall records (Wootton Bassett Rg) (Shootherill)

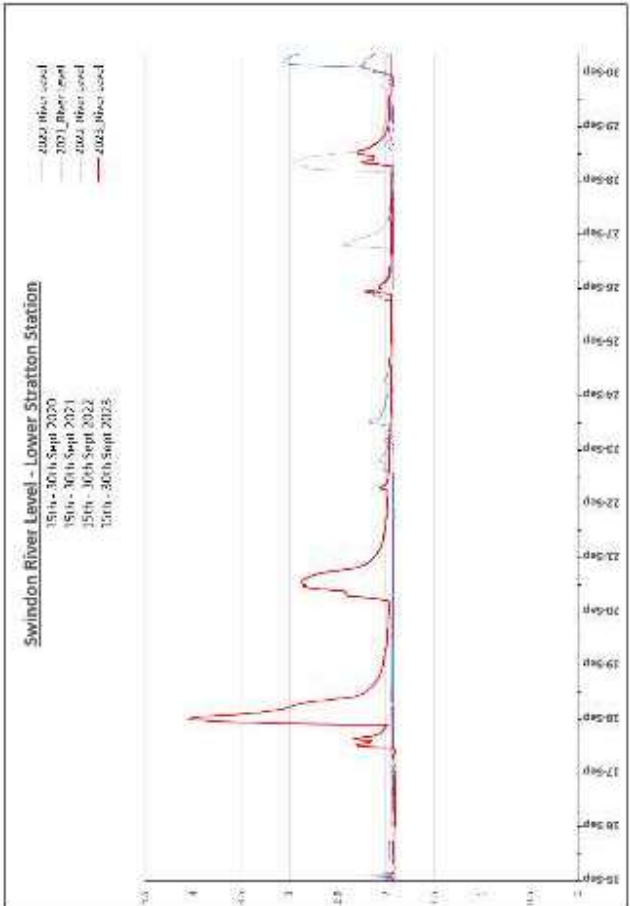
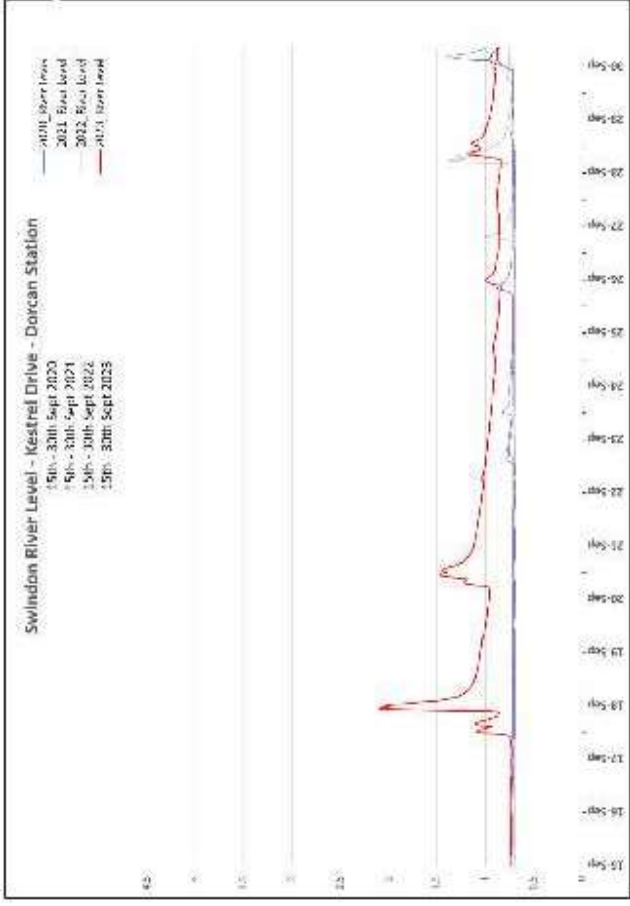
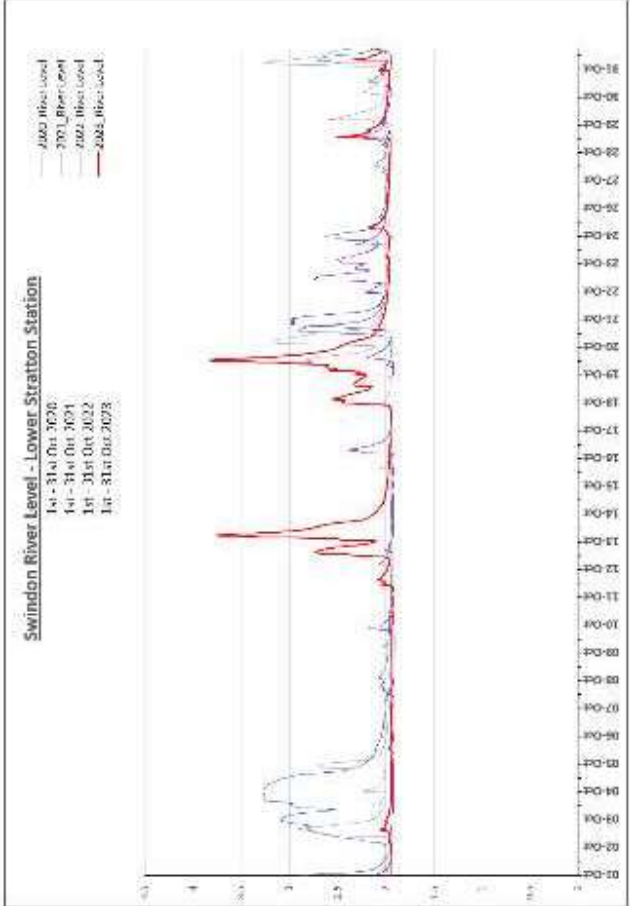
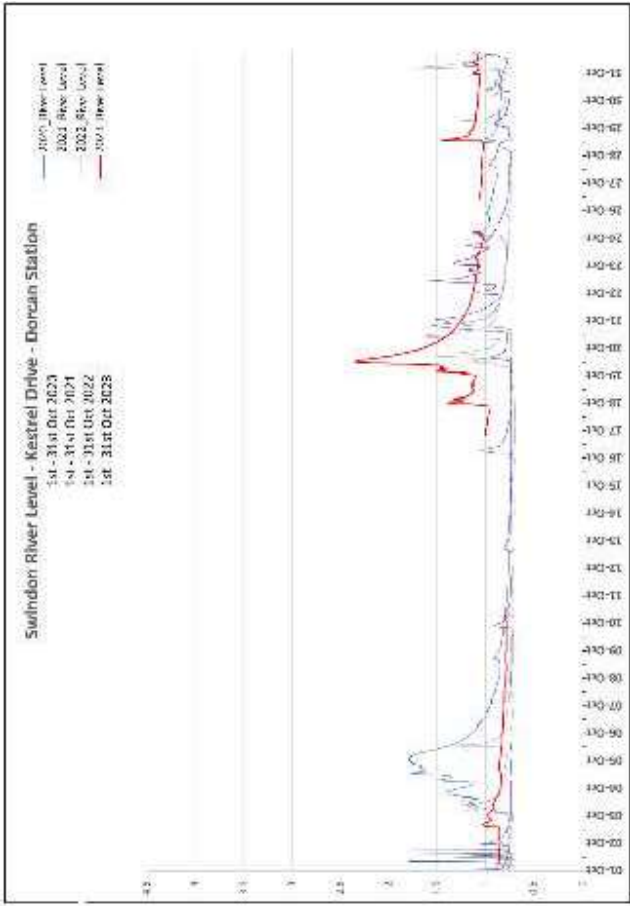
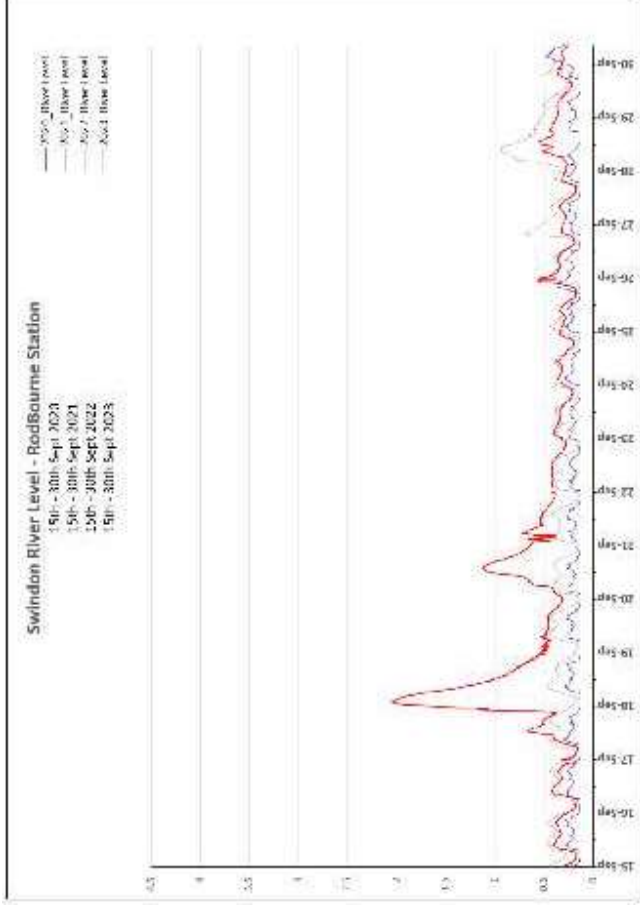
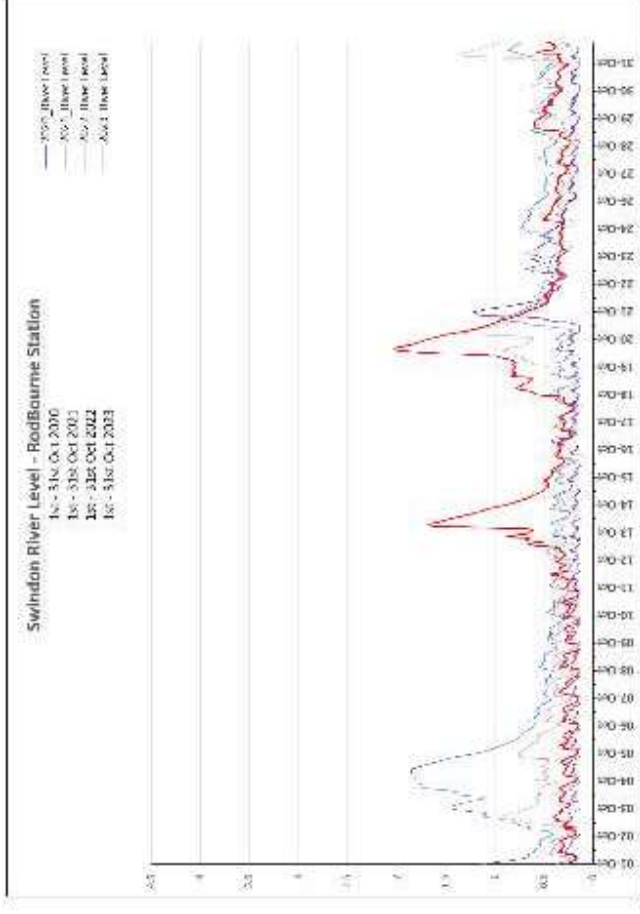
C.2 Rivers Levels at various measuring stations within Swindon

(Data collected from the Environment Agency main river gauge records)

This suggests rapid initial runoff from the catchment into the main river network. It is also noted that levels quickly fell again at all the river level stations to within typical ranges. The previous highest recorded events at each river level station was on 20<sup>th</sup> July 2007. Levels in the Cole and Ray systems came close to meeting those highest recorded levels.
